Bamboo as a New Retrofitting Material for Existing Masonry Walls with Improving the Walls Aesthetic View

Abstract— Sri Lankan architecture is mainly based on masonry since ancient time. Among different types of masonry, Un-Reinforced Masonry (URM) construction has possessed the local culture of Sri Lanka especially in home/residential building construction since ancient time. Unfortunately, URM buildings are the most vulnerable for earthquakes. It reveals that, the need of introducing proper techniques for retrofitting of URM buildings, especially for existing buildings is time essential. Bamboo is a unique building material in that it is strong in both rigidity and density; is now being used more prominently in all types of architecture. The objective of this study is to evaluate the performances of bamboo strips as an architectural material to retrofitting the existing URM walls against earthquakes.

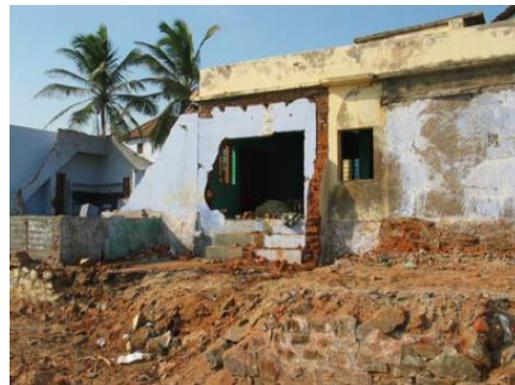
Figure 1: Failure of masonry Building against earthquake

Throughout the centuries, earthquakes have caused severe damages to human life and property in all around the world. Most of the deaths were recorded as a result of an earthquake was due to collapse of brick masonry structures as shown in Figure 1. December 26th 2004, when Sumatra Tsunami has adversely affected the Sri Lanka with the greatest human loss of around 30,000 and massive property damage. It is believed that there is diffused plate boundary in the making some 500 km south of the southern tip of the island (Dissanayake, 1999).

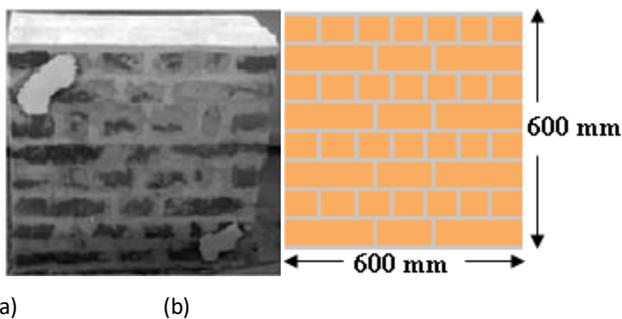
Figure 2: Wall configuration; (a) Un-reinforced burned clay brick masonry wall and (b) Wall geometry

A real scale model test makes possible to obtain data similar to real structures. Therefore, full scaled models were used in this experimental programme. Burned solid clay bricks (i.e., size of a brick: 215 x 102.5 x 65 mm) which are commonly used in constructing load bearing masonry walls in Sri Lanka, were used to build the test walls (Figure 2(a) and (b)).

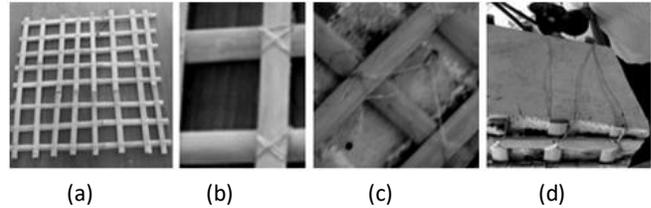
Figure 3: Bamboo strip mesh method; (a) Prepared bamboo mesh, (b) Binding cross points of mesh, (c) Connecting mesh on wall surfaces and (d) Connecting two meshes each other

Two meshes were prepared to retrofit the selected URM wall having 5 mm thick and 20 mm wide sixteen yellow bamboo strips were arranged in a mesh pattern with a pitch of 50 mm to prepare the mesh as shown in Figure 3(a), Each cross point of the mesh was tightly connected using galvanized steel binding wires (Figure 3(b)). The masonry wall was symmetrically retrofitted with two meshes as one mesh on each wall surface of 600 x 600 mm, using binding wires inserted through holes in the wall as shown in Figure 3(c). Afterwards, two meshes were connected each other (Figure 3(d)) at four wall surfaces of 600 x 215 mm with binding wires. Meshes were bonded each other due to purpose of giving effect of foundation, roof and supporting walls at bottom level, top level and left and right sides of the wall, respectively. The resulting structure was an integrated matrix, with strong connection between wall and the mesh.

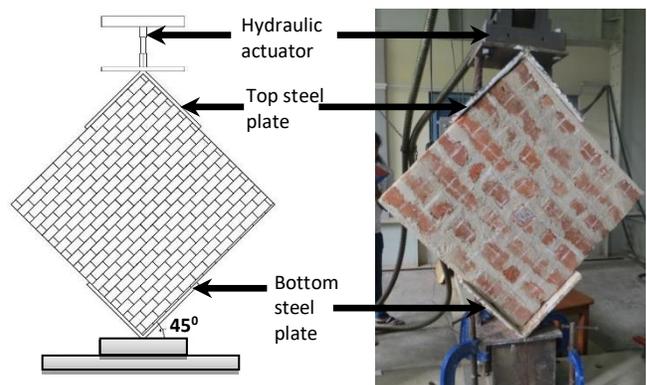
Figure 4: The test setup; (a) Schematic diagram and (b) NRUMW at the test setup

Two steel angle plates were used to bolt the specimens to the loading frame. A 5 mm thick plaster of paris layer was applied on both steel plates where the interface between the test wall and the steel plate. This layer is crucial to carry out a better load transformation from steel plate to the test wall. One of steel angle plates was bolt to hydraulic actuator and other plate was placed on a support attached to the loading frame just below the actuator as shown in Figure 8(b). Then, specimen was carefully installed into loading frame and the specimen was checked for vertical alignment using plumb bob.

Figure 8 shows the experimental setup used in the laboratory to determine the shear failure masonry walls and to evaluate the effectiveness of proposed retrofitting methods against in-plane static loads. Diagonal compression test which is available to investigate the in-plane diagonal shear strength of masonry walls was carried out on test specimens and ASTM E-519-02 standard guidelines were used in the test setup.

The load was applied on test walls along the vertical diagonal of the wall using the server controlled hydraulic actuator at a rate of approximately 0.1 mm/s under the displacement controlled method. The applied diagonal force on the walls and the corresponding displacements along the vertical diagonal (i.e., along the loading direction) of the walls were recorded over the time. Crack initiation and propagation and failure pattern of the walls were also observed.

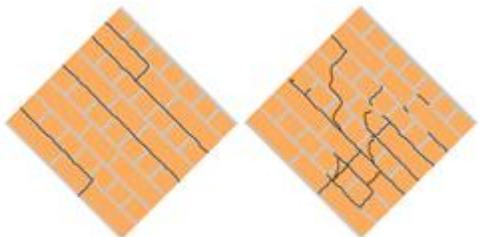
Figure 5 shows the crack patterns observed on control specimen just before its collapse. Crack initiation in URM wall was observed in the mortar bed joints and mortar head joints and cracks were developed and propagated along the mortar joints. There were no cracks initiated and developed through bricks. It could be observed that, propagation of cracks was in wider area on surface of wall with bamboo strip mesh (Figure 5(b)), instead of concentration few major cracks into specific area as in control wall.

Figure 5: Crack formation of test specimens; (a) Control wall panel (b) retrofitted wall panel

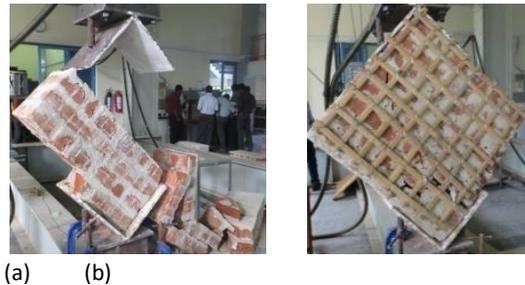
“Diagonal shear cracking” is the common masonry failure mode under seismic loads and happens for a combination of vertical and horizontal loads where the principal tensile stresses developed in the wall due to this action, exceed the tensile strength of masonry. Afterwards, cracks were along a bed joint causing sliding of the upper part at that location which is generally called as “shear sliding” (Figure 6).

Figure 6: Wall panels at the end of the test; (a) Control wall panel (b) retrofitted wall panel

The bricks have not been damaged at failure of conventional URM wall and bricks have been separated due to the failure of mortar joints (Figure 6(a)) leading to collapse of the wall. The main effect of the bamboo strip mesh is to restrain the separated masonry fragments for allowing the redistribution of the load within the masonry itself.

Vertical bands apply normal compression once sliding of rows (Figure 6(b)) occurs, resulted in increasing the masonry’s frictional resistance to shear sliding. Through friction, energy from alien stresses is dissipated. Vertical bands also redistribute the load eliminating the concentration of load at same masonry course but allowing deformation of wall panel. Horizontal bands directly bear load by resisting the separation of bricks within the same row allowing vertical bands to keep redistribution of the load over long period preventing or delaying loss of debris. Both types of bands together give an improving of ductility with rigid box like action of enclosures resulted in preventing the collapse of damaged masonry walls on occupants, passengers and nearby buildings.

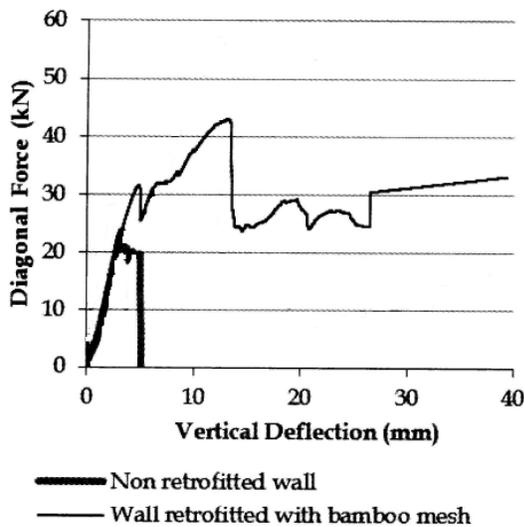
Figure 7: Load variation with deflection

Figure 7 shows the diagonal compressive force variation with deflection of vertical diagonal of wall along the loading direction for all the test walls with and without retrofitting. The load at critical crack initiation (i.e., also peak strength) of control wall was 26.70 kN. However, there was no regaining of strength again and no residual strength left after cracks appeared in control wall. The control wall exhibited an approximately linear behaviour up to first visible cracking and then failed suddenly along a diagonal step joint and bed joint when they reached their diagonal tensile strength.

In wall with bamboo strip mesh, initial visible cracking was followed by a sharp drop with remaining of 77.9% its peak strength. After it, subsequent strength drop was quickly regained due to characteristics of both elastic behaviour of materials (i.e., bamboo) and the arrangement of mesh formation. The peak load, after first visual cracking, for wall with bamboo strip mesh was nearly around 44 kN. At the end of the test, the control wall showed stepped joint sliding and bed joint sliding, the retrofitted walls with bamboo strip mesh did not lose its stability. This is due to the better rigid box like action by bamboo strip mesh. The wall with bamboo strip mesh also showed cracks which were larger in number, smaller in magnitude and propagated over wider area. Wall with bamboo strip mesh also kept residual strength in better manner compared to control wall (Figure 7). Bamboo strips have higher tensile and compressive strength which give higher frictional resistance against shear sliding resistant to avoid separation of bricks within same brick course of enclosures of wall with bamboo strip mesh vertical bands give higher frictional resistance against shear sliding and dissipate

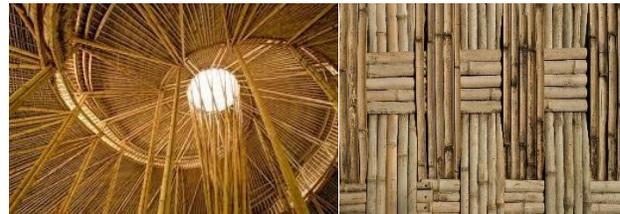
Figure 8: Bamboo as construction material (a) Roof and columns (b) walls

Bamboo is currently used as architectural material for constructing roofs and ceilings, walls and non-load bearing columns (Figure 8).
