Feasibility Studies on Sustainable Fisheries Infrastructure Development

AHR Ratnasooriya¹, SP Samarawickrama²

^{1,2} Department of Civil Engineering, University of Moratuwa, Sri Lanka

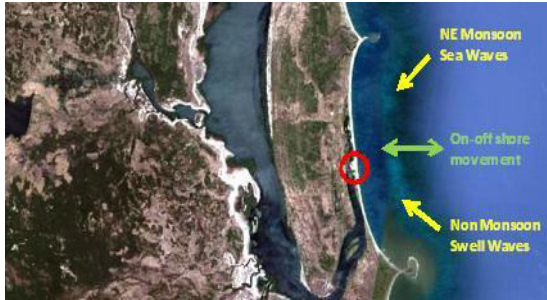
The site at which investigations were conducted is located in Vakara Central, at the outlet of a lagoon near the centre of a coastal cell formed by two natural headlands as shown in Figure 1.

Figure 1. Location of Vakarai Central
(Source of Image: Google Earth)

The coastal area is characterised by wide sandy beaches and sand deposits in shallow areas of the lagoon near the outlet and a wide sand bar across the outlet. The sand bar blocks the outflow from the lagoon but breaches during the north-east monsoon to release flood waters and once breached, it remains open for a few months. The site is located away from the areas sheltered by the headlands and is seasonally exposed to both swell and north-east monsoonal waves as indicated in Figure 1. Significant seasonal variations of coastline positions and steepening of beaches indicate high level of longshore and on/offshore sediment transport in the vicinity. In spite of small tidal range in coastal waters of the country, a potential exists for ebb and flood tidal currents through the channel across the breached sand bar formation with accompanying sand transport patterns. Significant variations in the form of the outlet and the lagoon sand deposits in the vicinity were also evident. The abundance of sand and the dynamic and complex nature of coastal processes and the high level of sand transport activity in the vicinity became clearly evident by the investigations.

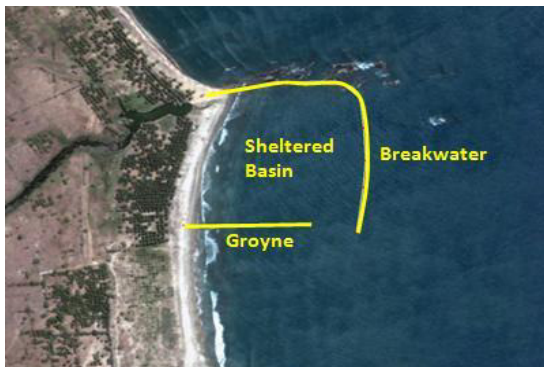
scale coast protection scheme was also recommended together with any fishery infrastructure development. The conceptual layout of a fisheries infrastructure facility shown in Figure 3 was proposed for further investigations.

Figure 3. Conceptual Layout of Proposed Developments in Palachenai

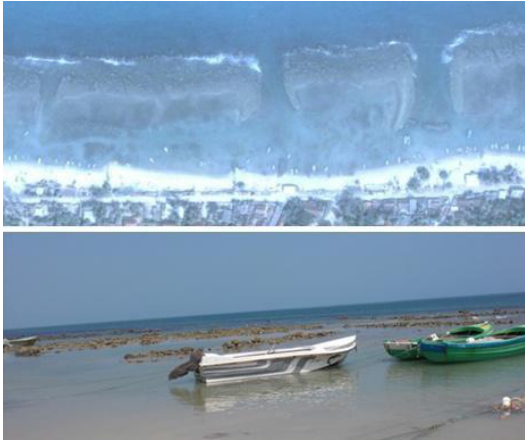
The coastline along the northern side of peninsula in Point Pedro is characterized by rocky/sandy beaches and a reef formation is located close (< 300 m approximately from the coastline) and parallel to the coastline as shown in Figure 5. Although the coastline, by its orientation, is potentially exposed to north-east monsoonal waves, protection against coastal erosion is provided by the reef formation along most of the coastline. The presence of reef formation has also resulted in a number of naturally sheltered basins in the area, suitable for mooring of fishing craft. Many of the Landing Sites in Point Pedro area are located in such basins. These include the Landing Sites in Thondamanaru, Valveddithurai, Athkiviladi, Polikandy West, Polikandy East, Sakkodai, Imparsiddy, Suppermadam, Koddadi and Munai. Mainly the smaller fishing boats are operated from these Landing Sites but, depending on the depths in sheltered areas behind the seaward edge of the reef formation, some of the larger boats, which have become operational

Figure 5. Northern Coastline: Point Pedro Area
(Source of Image: Google Earth)

The tsunami in 2004 has caused significant damages to the reef formation and spreading of broken parts of the reef in sheltered basins has caused difficulties in using the Landing Sites due to reduced depths and partial blockage of access channels. The cyclone in 2008 has also caused further damages. The improvement of fisheries infrastructure at Landing Sites for the operation of mainly the smaller fishing craft, in the area could generally be achieved by strengthening the natural protection provided by the reef formation. Raising the crest level of reef formation and strengthening of its seaward slope with the use of larger armor may be needed to provide effective protection. The clearing of scattered rocks from the access channels and sheltered basins would also be needed. Deepening of access channels and the basins may also be required at some of the sites and in such situations due attention need to be paid for and adverse environmental issues associated with any dredging of reef formations. A possibility also exists for the use of excavated and cleared material for the use in the strengthening of protection measures.

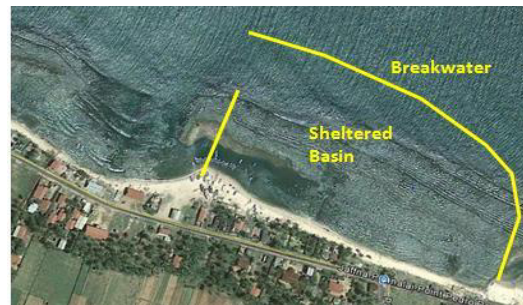
Figure 6. Conceptual Layout of Proposed Development
(Source of Image: Google Earth)

operational, the potential exists for other fishery harbor developments in the region, mainly due to the relatively smaller size of the harbor basin in Myliddy which may not be capable of meeting the needs of the expanding fleet of larger fishing craft in the area. In view of these considerations, recommendations were made for the development of a fishery harbor/anchorage facility in Point Pedro area at an appropriate location identified based on socio-economic, environmental and coastal engineering considerations. Appropriate protection measures, usually in the form of breakwaters would be required in such a development to provide a sheltered basin of adequate extent and depth against north-eastern monsoonal waves. A typical conceptual layout in the form of that shown in Figure 6 can be recommended for such a development. No severe adverse impacts associated with coastal erosion are envisaged due to such a development in view of the protection provided by the coastal reef formation in the area.

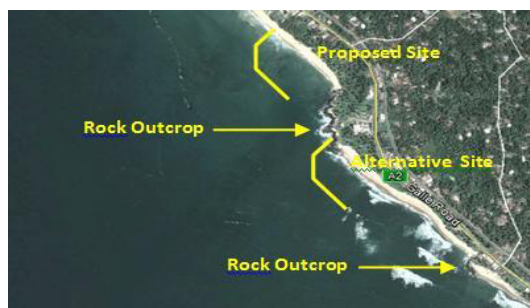
An investigation was conducted to assess the feasibility of developing a fishery landing site in Galbokka in Rathgama in the Galle District. The site had been identified based on the availability of land to develop shore facilities. The location of the site is shown in Figure 7. A wide sandy beach exists in the area next to a rock outcrop, from which the beach extends uninterrupted for a few kilometres in the north-western direction. The investigation revealed significant seasonal variation in the beach, in the order of up to 40 m in the vicinity of the project site indicating high level of sediment activity. A beach profile with a steep gradient is formed at the site during the south-west monsoon, which, together with adverse wave conditions, makes it difficult for landing/mooring of fishing

craft. Due to the orientation of the beach at the site, it is directly exposed to the south-west monsoonal waves and no sheltering effect is provided by the rocky outcrop. In view of the exposed nature of the site, it is evident that appropriate coastal structures are required in any proposed development to provide a safe mooring and landing environment at the site. The layout of such structures will depend on local bathymetric and wave conditions but, based on the site conditions observed and considerations of exposure and protection requirements, a conceptual layout in the form of that shown in Figure 7 can be identified for further investigations.

Figure 7. Location of the Site in Galbokka and Conceptual Layout(s) for Further Investigations
(Source of Image: Google Earth)

In view of the potential adverse impacts associated with the developments at the proposed site, as an alternative, the technical feasibility of another site was investigated which is located next to the proposed site on the opposite side of the rocky outcrop, as shown in Figure 7. The sandy beach at the site extending from the outcrop is interrupted by another smaller outcrop nearby (Figure 7) forming a smaller coastal cell in which relatively lesser extent of sediment movement is apparent. The larger outcrop provides partial protection from south-west monsoonal waves which can be enhanced by a coastal structure extending from the outcrop as shown in Figure 7. From a coastal engineering point of view, it is apparent that this site is more suited for development of fisheries infrastructure but, similar to the proposed site, detailed investigations are required to assess the development potential in detail.
