Review of Impacts on Coastal Zone Due to Poor Riverine Flood Controlling Mechanism: A Case Study in Kalutara Coastal Zone, Sri Lanka

Abstract: Sri Lanka has attractive coastal zone that contributes to the economic value of the country by promoting tourism-related activities. In addition, due to the existence of natural coastal features, the coastal areas of the country have become the main obstacle to the natural coastal hazards as Tsunami. However, the coastal area of Kalutara is currently facing serious problems due to the anthropogenic activities. Kalutara is also highly vulnerable area for riverine flood of Kalu Ganga. In May 2017, a considerable portion of naturally formed sand barrier at Kalu Ganga River outfall was removed as a strategy to risk reduction process of flooding. The focus of this study is to review the negative impacts of this risk reduction process. To achieve this objective, the bathymetric profiles and the Google Earth satellite images from 2013 to 2019 were collected and analysed. The review data is shown a chronological variation of the sand barrier at the river outfall. Also erosion in the Kalutara coastal region is accelerating after May 2017. Moreover,

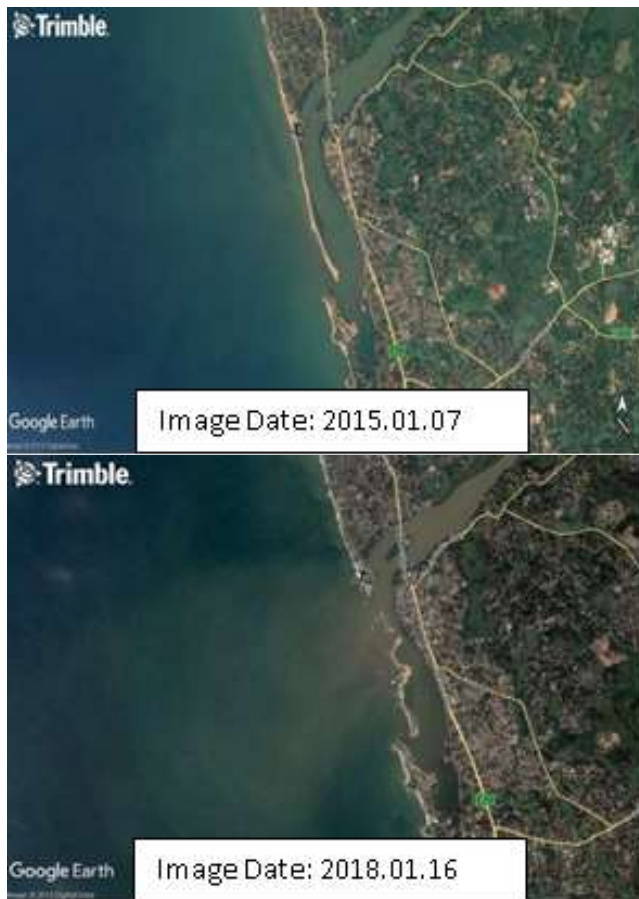
Figure 2. Before and after demolition of sand spit bar

The figure 2 is shown the example Google Earth image comparison before and after demolition of the sand spit bar on 2015-01-07 and 2018-01-16 respectively. The several comparisons were examined using extracted Google Earth images from Google Earth Pro online software from 2013 to 2019. Generally, most variation of the sand spit bar and adjacent area in Kalutara coastal indicates after the May, 2017.

The beach morphology variation was observed by means of Google earth images extracted from Google Earth Pro online software from 2013 to 2019. After 2017, it is indicated that new sand spit bar created in different location within the same area. It is because variation of hydrodynamic and sediment transport pattern after the incident in May 2017. Moreover, the severe erosion is shown in the place where old sand spit bar connected to the land. The less supply of sand and energetic wave impact on beach face are the reasons for severe erosion at the place where old sand spit bar connected to the land.

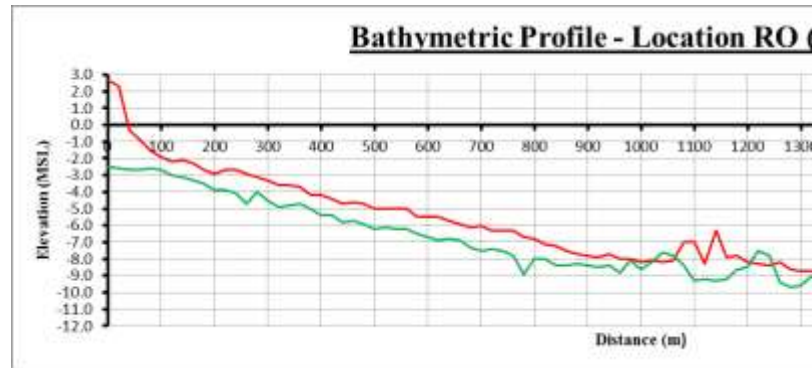
Figure 3. Bathymetric profiles at river outlet

The bathymetric profiles at nine locations compared in Kalutara coastal area before and after demolition of the sand spit bar and figure 3 is shown the bathymetric profiles at river outlet regarding separate time durations. After examine all the bathymetric profiles before and after demolition of sand spit bar, It is observed that the water depths were increased after demolition sand spit bar (deepened the sea bed)

The comparison of bathymetric profiles was indicated deepening of sea bed at the area. Such deepening in the nearshore zone can cause the sea waves to break very near to the coastline. This might also lead to generate new diffraction patterns resulting differential coastal accretion and erosion scenarios. Then, the erosion is accelerated in the area after May, 2017.
