# Ceramic Tile Waste as Fine Aggregate for Marine Concrete Modules In Sri Lanka

**Abstract:** Construction waste has a major impact on the environment. Reusing and recycling this waste can reduce the extraction of raw materials and help waste management. Therefore, this study was focused on ceramic tile waste which is released in the squaring process of tile manufacturing, and to develop a design to protect the coastal area as an end product. A mixed design based on BS 5328 with M15 targeted strength was achieved with the use of cement, water, and aggregates, where fine aggregates were replaced with ceramic tile waste in 25%, 50%, 75%, and 100%. XRD test was conducted to test the constituents of ceramic tile waste. Results indicated that a higher compressive strength was achieved when the replacement was at 25%. No heavy metals were detected in the XRD test. This study concludes that the optimum percentage and the water/cement ratio would be 25% of fine aggregates replaced with ceramic tile waste with a 0.5 W/C ratio. Two designs were introduced and samples were deployed in Polhena beach, Sri Lanka. The growth of corals on the designed structure indicated the appropriateness of th

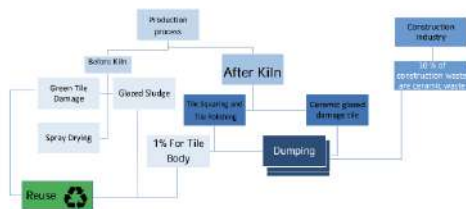
The Ball clay, Kaolin, Quartz, Feldspar, Silica, and Dolomite are used for the production of ceramic tiles and they can be easily found in Sri Lanka (Liyanage & Ranasinghe, 2019). The production of these tiles follows five main steps, raw material extraction, grinding and mixing the extracted materials, granulating by spray drying, pressing, firing, and finally polishing and glazing [4]. Due to the increment in infrastructure development in recent years, Sri Lanka has focused on using natural aggregates and waste reduction techniques (Deiyagala, et al., 2017). Currently, manufacturers are disposing the ceramic tile waste to fill the low lands and abandoned mines. Although ceramic tile waste is generated before the kiln process is reused, waste that is generated after the kiln process has become a real threat as it is disposed to the environment (refer to Figure 2).

Figure 2. Production and waste generation process of ceramic tiles.

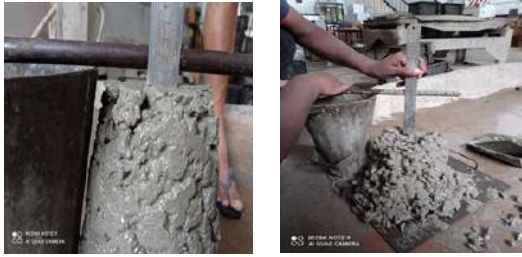
Figure 6. Conducting Slump test in the lab

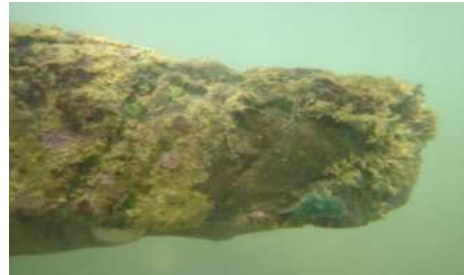
Figure 11. After deploying the samples to the research area, coral development was observed after 2 months

The deployed samples and designs A & B were checked after 2 months, 6 months, 1 year, and 2 years (refer to Figure 11-18) for the growth of corals. It was identified that even without planting the corals on the structure, they have grown confirming the appropriateness of the product.

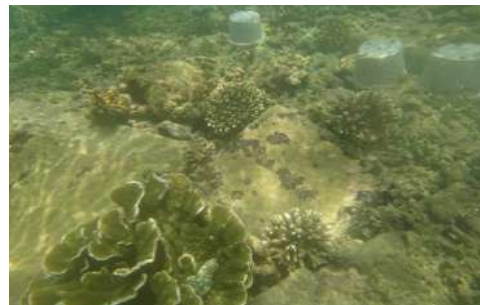
Figure 12. After deploying the samples to the research area, coral development was observed after 2 months

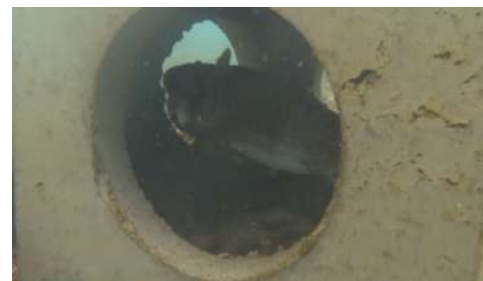
Figure 13 Puff fish choosing Marine Condo as its habitat

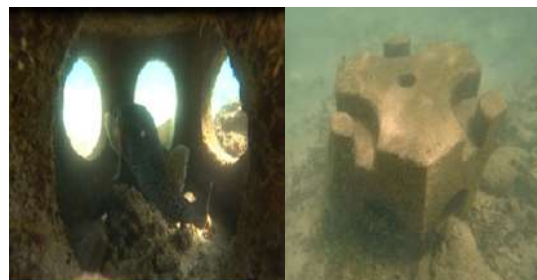
Figure 14. Design B after 1 year of deploying

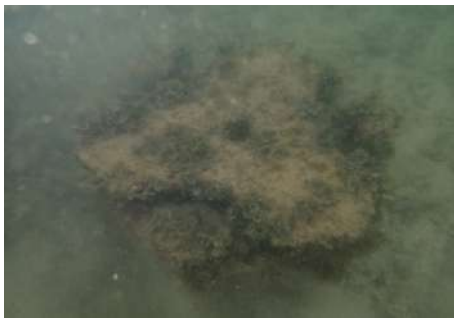
Figure 15. Coral development after 2 years of Design B

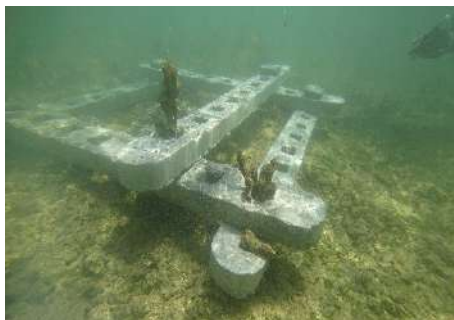
Figure 16. Design A after 3 days of deploying the sample

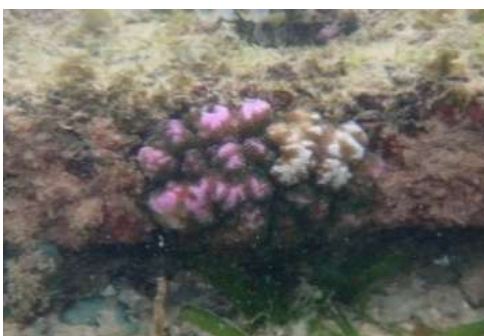
Figure 18. Development of corals on Design A after 2 years of deploying the sample.
